THE BOUNCING BOTTLE

A housewife is burned on both feet when a bottle of drain cleaner is accidentally knocked off a shelf and breaks, releasing its contents of sulfuric acid. A lawsuit is launched against the distributor, but what then?

© 1982 by the American Society for Engineering Education.
Written by C. O. Smith, College of Engineering and
Technology, University of Nebraska, Omaha, Nebraska.

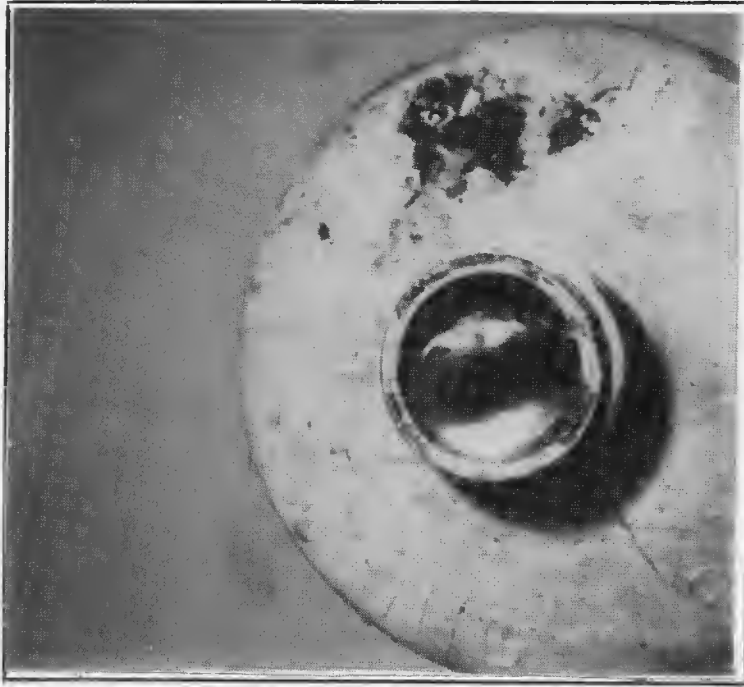
Some six years after the accident, the top of the bottle in question with its cap appeared as shown in Photograph A1. When the cap was removed, a seal across the mouth of the bottle was found to be partly detached as shown in Photograph A2.

Photograph A2 Top of bottle with cap removed showing seal attached at left and detached at right. Liner seal was attached over about 1/4 to 1/3 of periphery.

It also appears that the procedure for putting a seal across the mouth of the bottle is reasonable. There is some question about the suitability of aluminum foil in the "wafer" since aluminum is not resistant to attack by sulfuric acid. This apparently was of some concern since D2 had raised a question about lead foil with D5.

The seal on this specific bottle ruptured, at least on dropping and rupture of the cap, if not before. There is no way of determining if the seal had ruptured before dropping nor of determining the specific cause of seal rupture. It is foreseeable that a few will be inferior on a purely statistical basis.
